Improving Strength of Postbuckled Panels Through Stitching

Dawn C. Jegley

NASA Langley Research Center Hampton, VA 23681

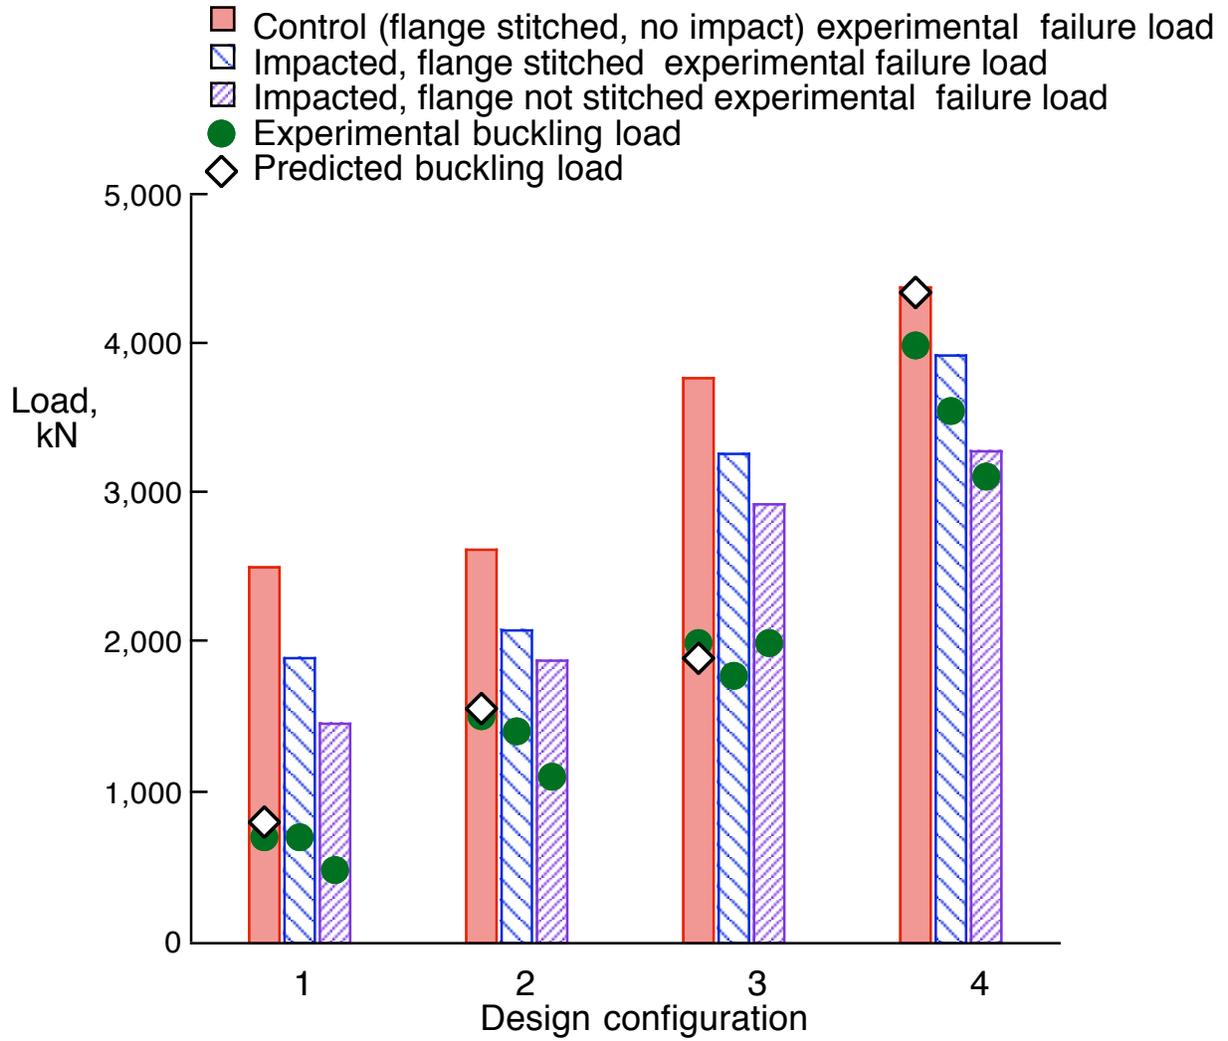
Figure 11. Buckling and failure load for all configurations.

all control panels. Buckling and failure loads for all control panels are shown in figure 11 where the open symbols represent the predicted buckling loads, the filled symbols represent the experimental buckling loads. Experimental and predicted buckling loads are in good agreement. Failure loads of the control panels are represented by solid bars. Control panels supported loads of 1.1 to 3.5 times the buckling load.

Two panels of each configuration were subjected to impact damage prior to compressive loading. All impact-damaged panels failed at loads less than their comparable control panels, as shown in figure 11 where the cross-hatched bars represent failure loads of the impact-damaged panels. Buckling loads were not as severely effected by impact damage compared to the failure loads. As illustrated in the figure, the failure loads of the control panels are 10-20 percent greater than failure loads of the panels with skin-to-flange stitching and impact damage. The failure loads of the control panels are 20-40 percent greater than the failure loads of the impact-damaged panels without skin-to-flange stitching. Photographs of comparable stitched and unstitched impact-damaged panels with configuration 1 are provided in figures 12 and 13, respectively, to demonstrate the difference in failure modes. There is little difference in the appearance of the failed stitched control panel shown in figure 7 and the failed stitched impacted panel shown in figure 12. Neither stitched panel demonstrates significant skin-stiffener separation. However, without stitching, the flange can separate from the skin over lengths greater than 140 mm, as shown in figure 13. Stitching suppresses this delamination and limits the damage region. While stitching does not bring the impact-damaged panels failure loads up

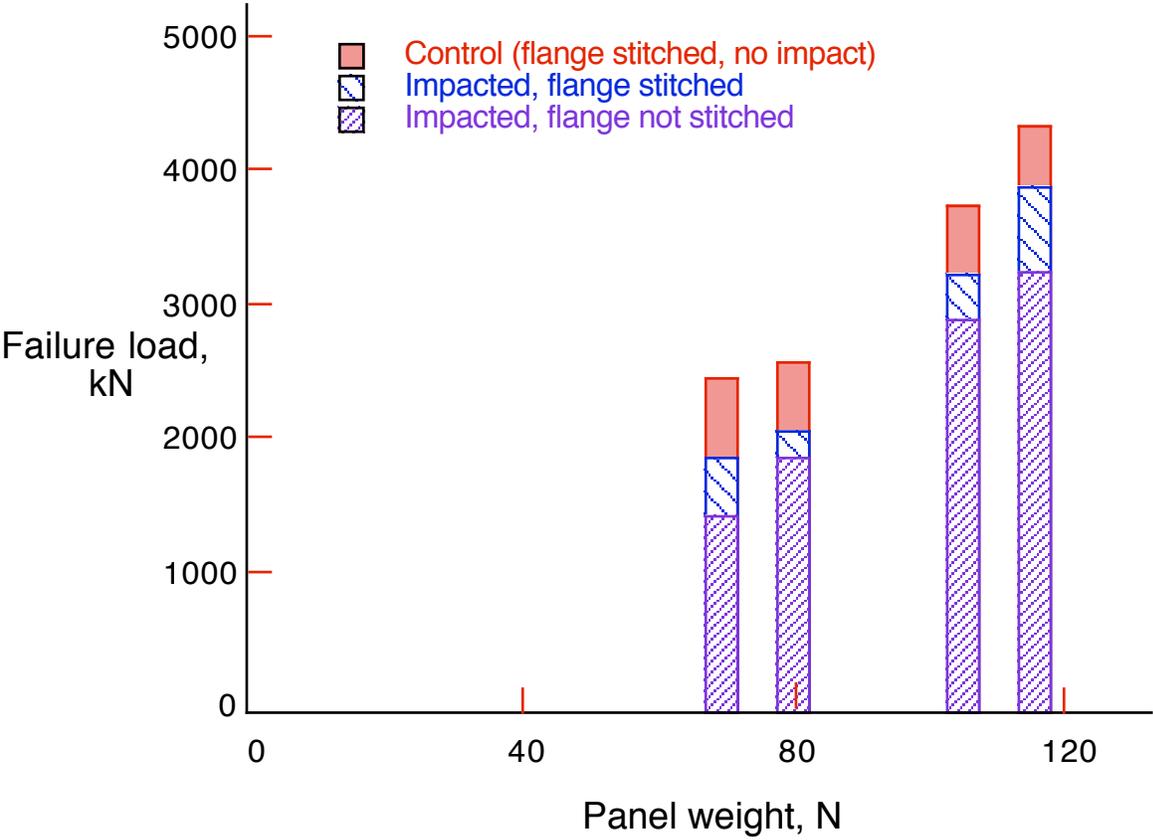
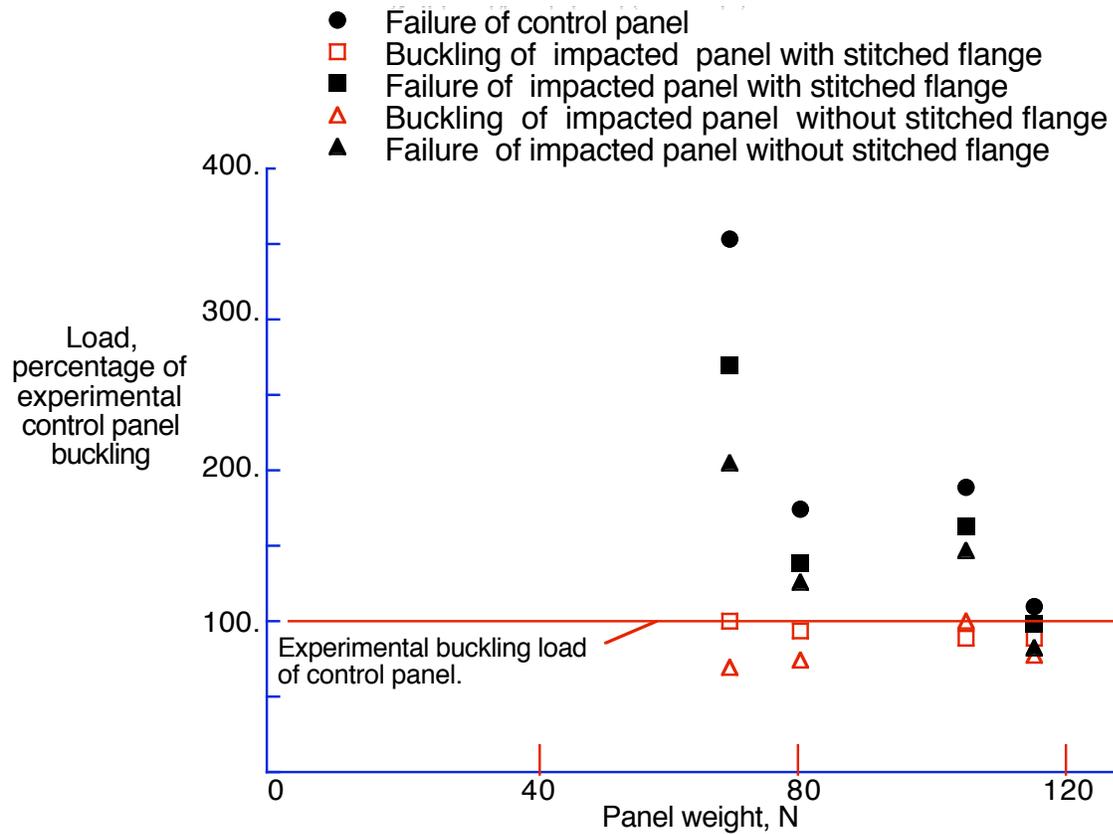
Figure 14. Panel failure loads.

If impact damage tolerance is the critical criterion for design of compression panels which are expected to operate into the postbuckling region, stitching can increase the design loads for minimum gage panels. A comparison of weight and failure loads for the four configurations of panels is shown in figure 14. Panel weight ranged from 70N (15.8 lb) for configuration 1 to 116 N (26.1 lb) for configuration 4. Failure loads for the twelve tested panels are shown in figure 14a where open bars represent control panels and cross-hatched bars represent impact-damaged panels. Buckling and failure loads are normalized by the buckling load of the control panels and are shown in figure 14b where open symbols represent buckling loads and filled symbols represent failure loads. Based on a percentage of load, the largest benefit of stitching is for the lightest weight panels, where the impact-damaged panel with the stitched flange supported 30% more load than the impact-damaged panel without stitching through the flange. Less than a 5% increase in failure load due to stitching can be seen in the other three configurations.
